May 12, 2009

## J/80 Review & Best Practices - Part I

Following two separate incidents in the past 12 months where 15+ year old J/80s suffered apparent keel stub failures, J Boats has compiled, with the help of several industry experts, the following “best practices” inspection, maintenance and use guide for J/80 owners. We urge each owner to read carefully the recommendations, to proactively and periodically inspect all critical components of your boat, and to contact anyone in the J/80 network of dealers, builders and class associations if you need any assistance.

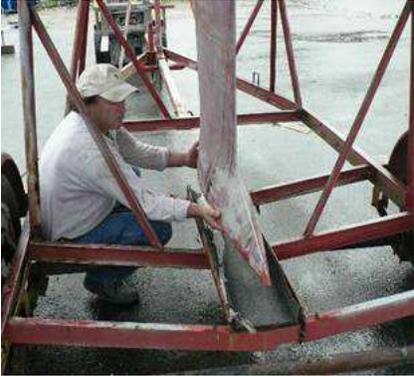
1. With your boat suspended from travel lift straps (OK) or braced in a cradle (best) or trailer (good), grab the keel at the bottom and forcefully rock it back and forth. This **tip deflection test** on a deep keel boat should create a small amount of flex over the keelspan and sump (if solid fiberglass like the J/80), but there should otherwise be minimal movement from side to side. When you release the keel it should immediately return to position (and not continue to cycle). It is also important to have someone belowdecks to check for movement in the keel floor or bilge area, or any evidence that the sump is moving independently of the keel floors.

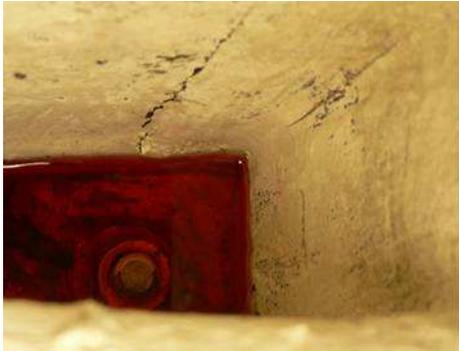
5. Remove all floorboards (both fixed and unfixed) and the ladder and thoroughly clean and dry all bilge components. With flashlight and mirror check all keel floor to hull intersections, including all edges of tabbing for any cracking or debonding. The integrity of the molded keel sump relies primarily on the keel floors and their secure attachment. If the keel and sump have excess movement, it is likely that the tabbing of one or more keel floors is compromised in some way (i.e. the floor is floating free from the hull). The picture to the right shows an example of delaminated tabbing. If there is any sign of different color gelcoats or paint, it is likely the keel sump has been previously repaired. When in doubt, sand away any gelcoat, clean area with a solvent, and look for white crazing in the laminate-- this may be a sign of delamination. Have a surveyor immediately inspect this area for structural integrity.

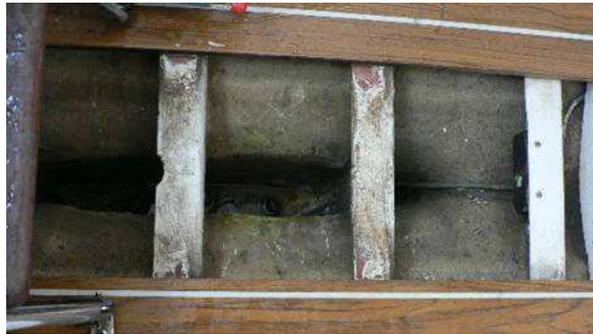
1. Care should be taken to avoid having standing water in the bilge. Not only does standing water accelerate corrosion of wiring, fasteners and keel bolts over time, it ruins floor boards and interior woodwork. As the gelcoat/ paint ages in the bilge area, bilge water can eventually seep into the fiberglass laminate by way of pin holes in the gelcoat and weaken the fiberglass laminate structure. The *process of hydrolysis* can be initiated

in the fiberglass laminate *anytime* there is ingress through cracks in the paint/gelcoat in the bilge. *The process of hydrolysis is persistent and invisible- it's water that chemically degrades the quality and strength of the laminate over time.* Bilges (all areas under the floorboards, not just the centerline bilge) should be cleaned thoroughly once per year and then every five years recoated with fresh gelcoat or epoxy paint to ensure proper protection. In northern climates, water turns to ice in the winter. If moisture gets into the laminate and freezes, this can rapidly accelerate deterioration in the laminate. The New Hampshire Materials Testing Labs website ([www.nhml.com](http://www.nhml.com)) has an informative article on hydrolysis, see Newsletter of May 1, 2006.

Here's a J/80 bilge that hasn't seen soap in years. Note evidence of high water present over a long period of time.

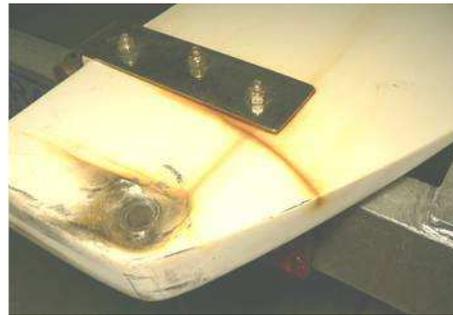
1. The J/80s rudder straps and gudgeons should be checked on at least an annual basis for corrosion or cracking. In salt water environment, these fittings should be replaced every 10 years and rebedded with Sikaflex or Boatlife every 4-5 years. If you need to mount new straps with a different bolt pattern, have the old holes properly repaired so as not to weaken the structure of the rudder and if necessary, replace the backing plate inside the transom wall.

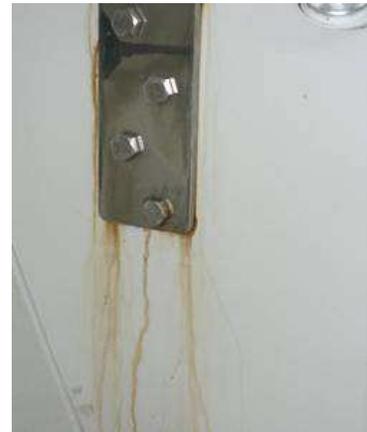
3. **Chainplate fittings-** the J/80 bulkhead is a composite structure of marine-grade plywood, laminated fiberglass and gelcoat. Both port and starboard chainplates should be checked at least annually, with new sealant applied under the deck cover plate whenever the rig is resteped and tensioned or at least once per year, which ever is sooner. Look for leaks around the chainplates where they intersect the deck. See Appendix B photo #1. If any long-term leaking is noticed, consider completing unbolting the chainplates, removing all the bedding compound and inspecting the deck and bulkhead laminate for any water ingress. Most J/80s have high density foam core in this area, but there is still a chance there may be core damage. If any of the core is damaged, remove the damaged area by reefing out the core and replace the area with a WEST epoxy repair kit using the filler to create a paste and then file the hole into shape. Another technique that can help prevent “wicking” of moisture along the stainless plate is apply a strip of metal primer to ensure a bond with the sealant. If any of the chainplate bolts are corroded, they should be replaced.
